SUBJECT: LA-6 Model.

DATE: October 31, 1933.

We release herewith the third installment of Machine Service Bulletin No. 161, Plates 22 to 28 inclusive, which illustrate and describe how to adjust the mechanism not covered in the first installment of this Bulletin.

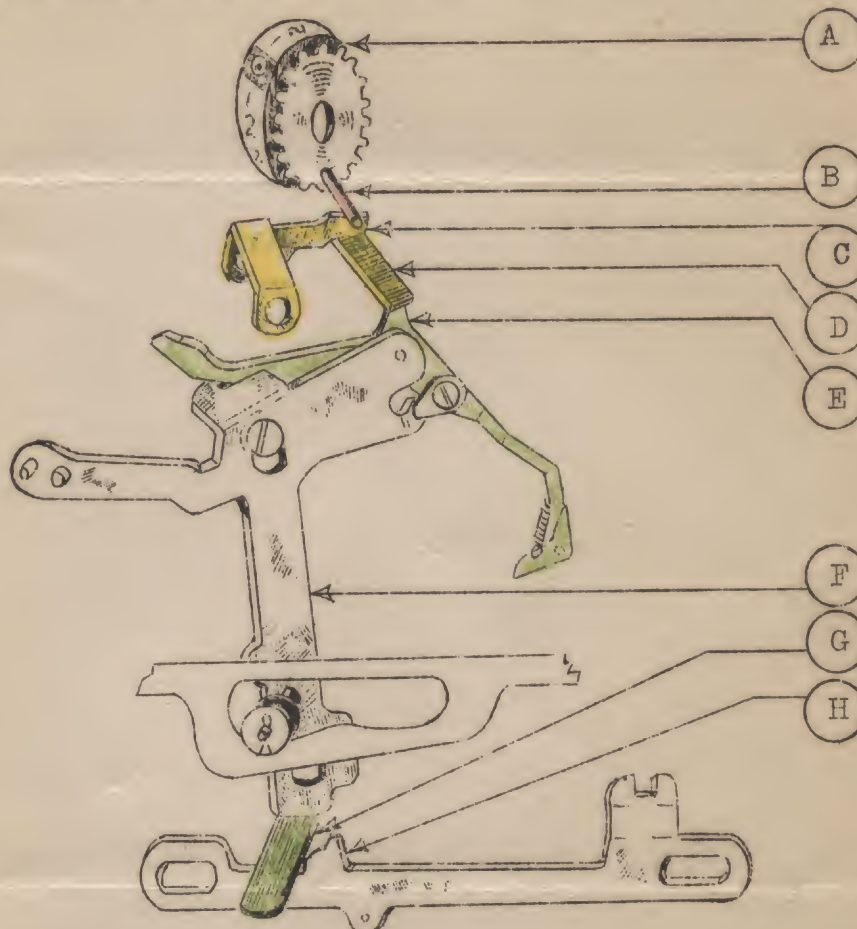
FIG. 1

At the completion of a problem in automatic multiplication, the figure "one" which remained in the upper right hand dial is replaced by the "zero", due to the lug (D) seating on (E), causing an upward movement of (C) which restores the pin (B) to its neutral position. The above operations occur only when lug (G) is latched on (H). If lug (D) is bent too low, dial (A) will not clear out when the carriage crank is turned. If lug (D) is not bent low enough, the zero will not return to its neutral position.

When the lug (G) is unlatched from (H), clearance of .010 should exist between the bottom of lug (D) and the tip of (E). This clearance is obtained by bending lug (D) upward or downward to suit.

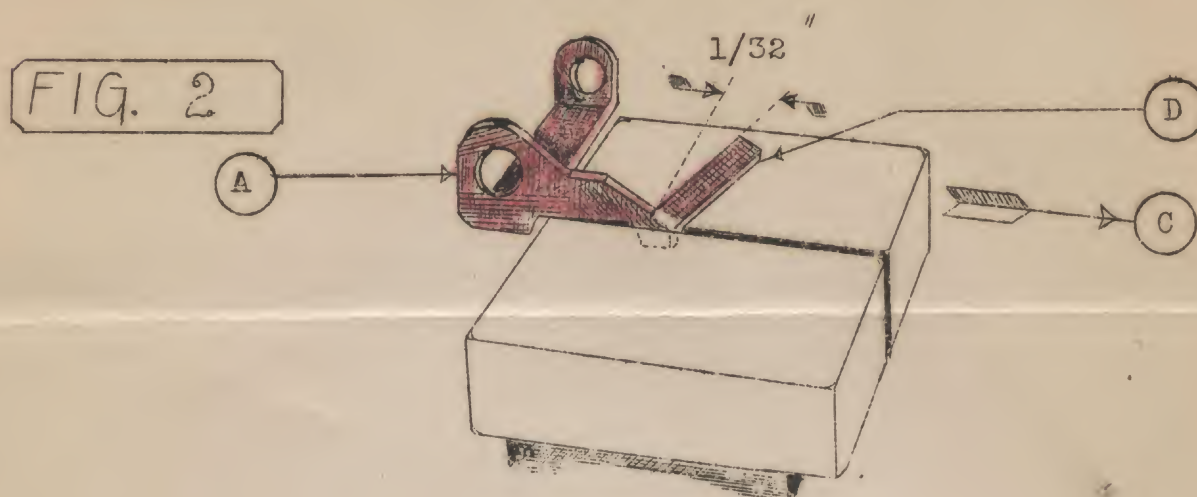
Before installing the return arm (A) in the carriage, clamp the arm securely in a vise as shown and using parallel pliers carefully bend the lug (D) in the direction of arrow (C) approximately $1/32$ ". This will assure an engagement of lug (D) with the point of (E), Figure 1, Plate 22.

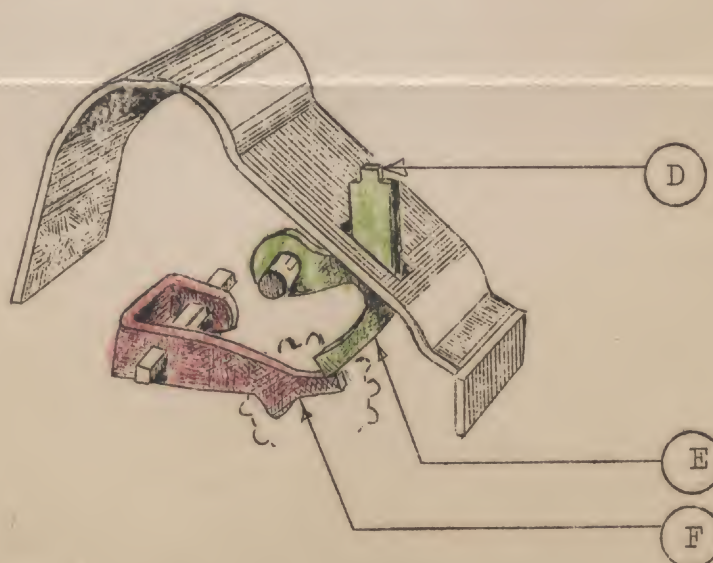
When the carriage is placed in any position with the exception of the extreme left and the constant key (D) is depressed, the lug (E) on the constant key (D) should engage the trip pawls (F) as shown. If the lug (E) fails to engage (F), bend the lug (E) with kit tool #14 until a direct alignment of (E) with (F) is obtained.

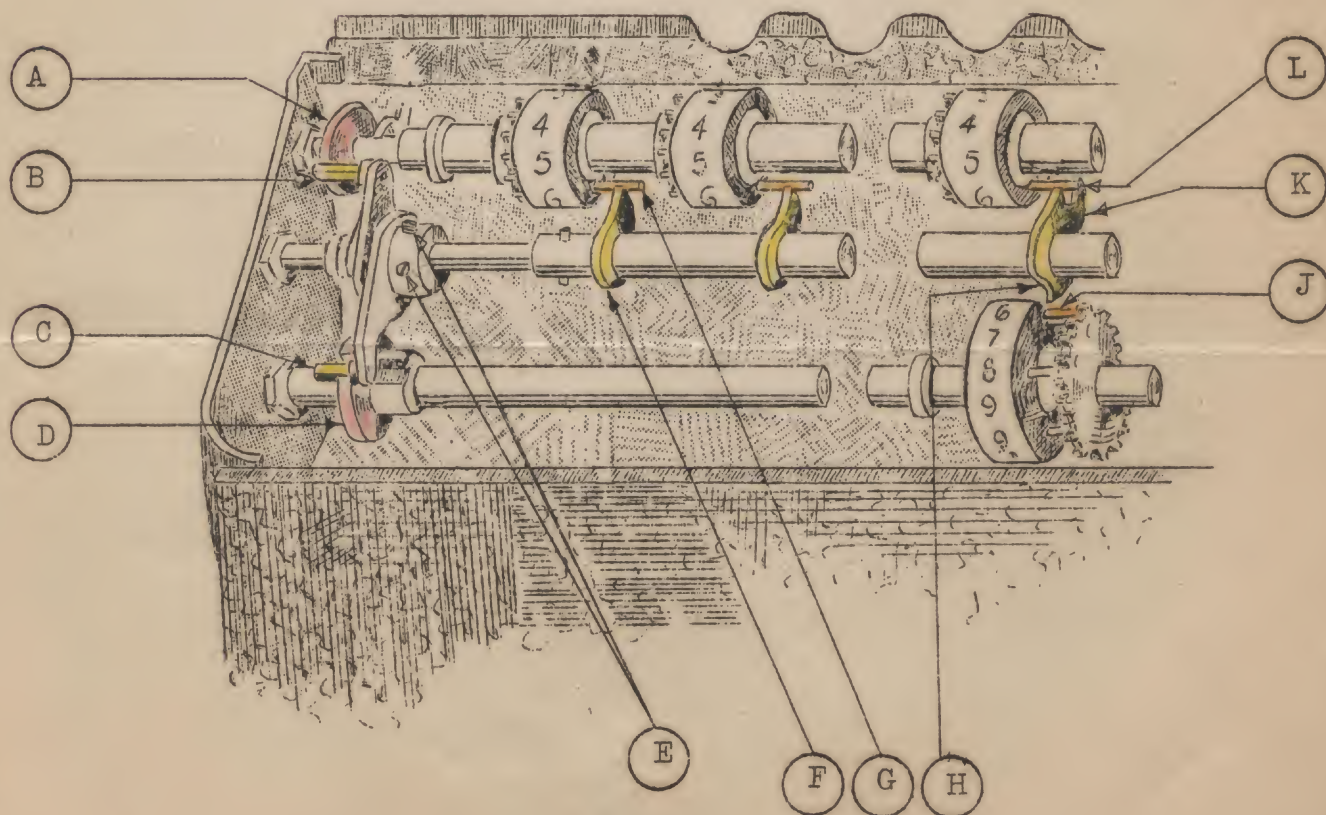
FIG. 4

Register figures in the lower dials; turn the carriage clear crank slowly and note the engagement of the fingers (F) and (K) with the clear pins (G) and (L). The fingers should engage the pins (G) and (L) with an approximate $\frac{1}{3}$ hold, providing extension (H) engages pin (J) while the upper dials are being cleared. Set screws (E) provide an adjustment of pins (B) and (C) in relation to cams (A) and (D) for regulating the hold of the fingers (F) and (K) on pins (G), (J) and (L).

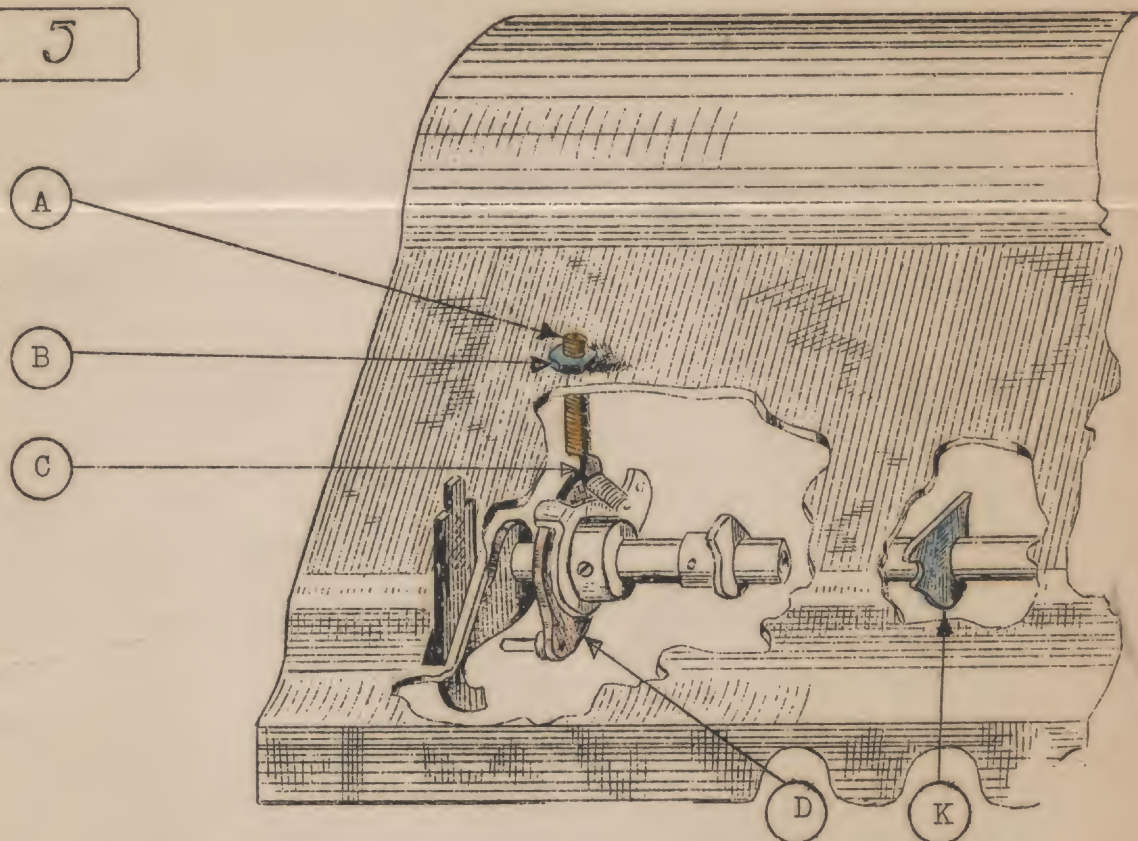
FIG. 5

Set screw (A) is provided to limit the movement of arm (C) and the trip rod locator assembly (D), thus controlling the position of pawls (K) in their proper relation to pin (L), Figure 4, Plate 24, when setting in a constant on the registering dials. After the correct adjustment has been determined, tighten nut (B) securely.

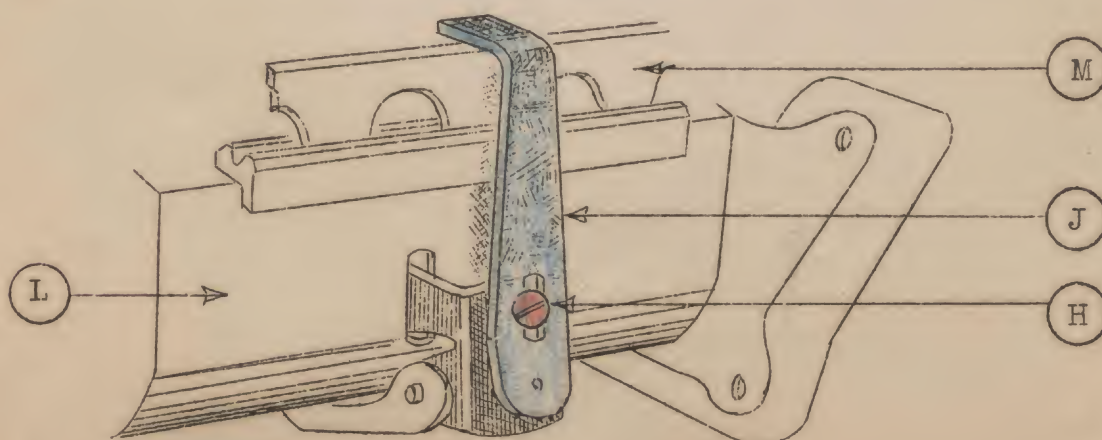
FIG. 6

The lock bar (J) on the through unit (L) is adjusted to the carriage rack (M) by loosening screw (H) and positioning the lock bar (J) upward or downward to suit. After the correct position has been decided, tighten screw (H) securely.

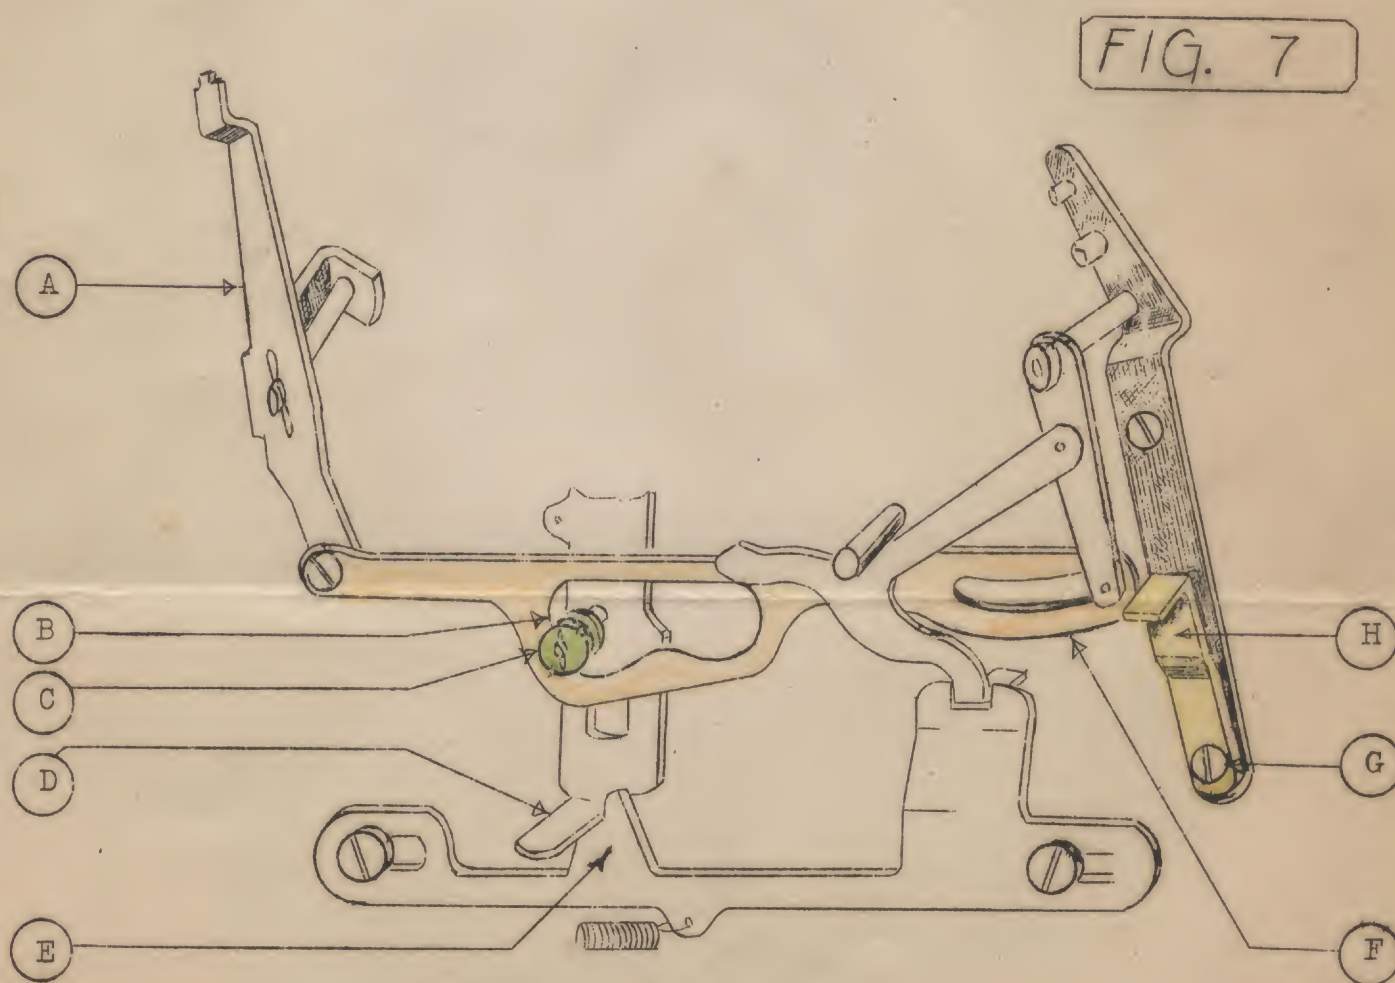
Blank (H) is provided to prevent a too-hasty unlatching of (D) from (E) which is caused by blank (B) striking roller (C) when the multiplication lever (A) is automatically restored to neutral. Approximately .015 clearance should exist between the lug of blank (H) and link (F) when the multiplication lever (A) is positioned as shown. This clearance may be obtained by loosening screw (G) and positioning blank (H) to suit. After the correct adjustment has been made, tighten screw (G) securely.

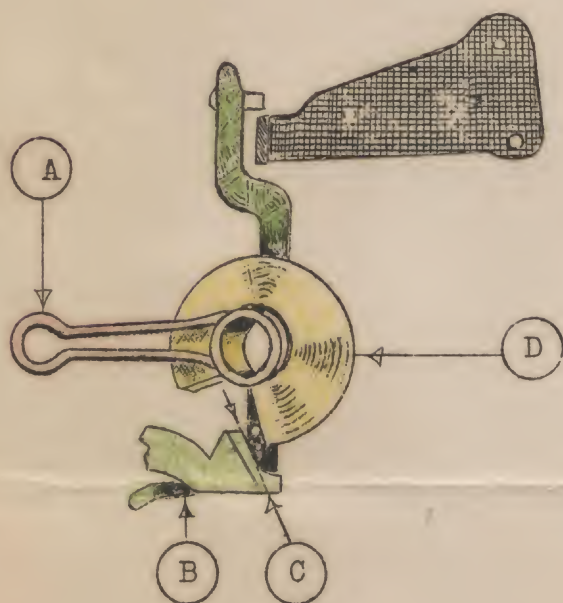
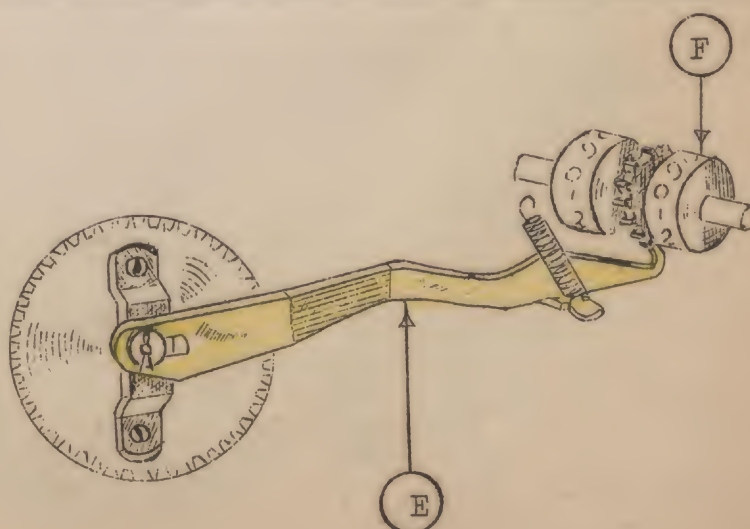
If during automatic division incorrect figures appear in the lower right hand dials, it is due to lock (B) striking the edge of cam (D) when the cycle stop arm is positioned against the bumper pad, thereby not allowing the lock to raise sufficiently high to permit the shifting of the carriage. This delay allows the counting finger (E), Figure 9, to engage the registering dials (F) twice and register accordingly.

This condition may be overcome by replacing the carriage lock cam with a cam having a larger notch or grinding $1/32$ " off the carriage lock (B) at (C), being careful to keep the original angle.

This condition may also be remedied in some cases by increasing the tension of the brake springs (A) on the carriage lock cams (D).

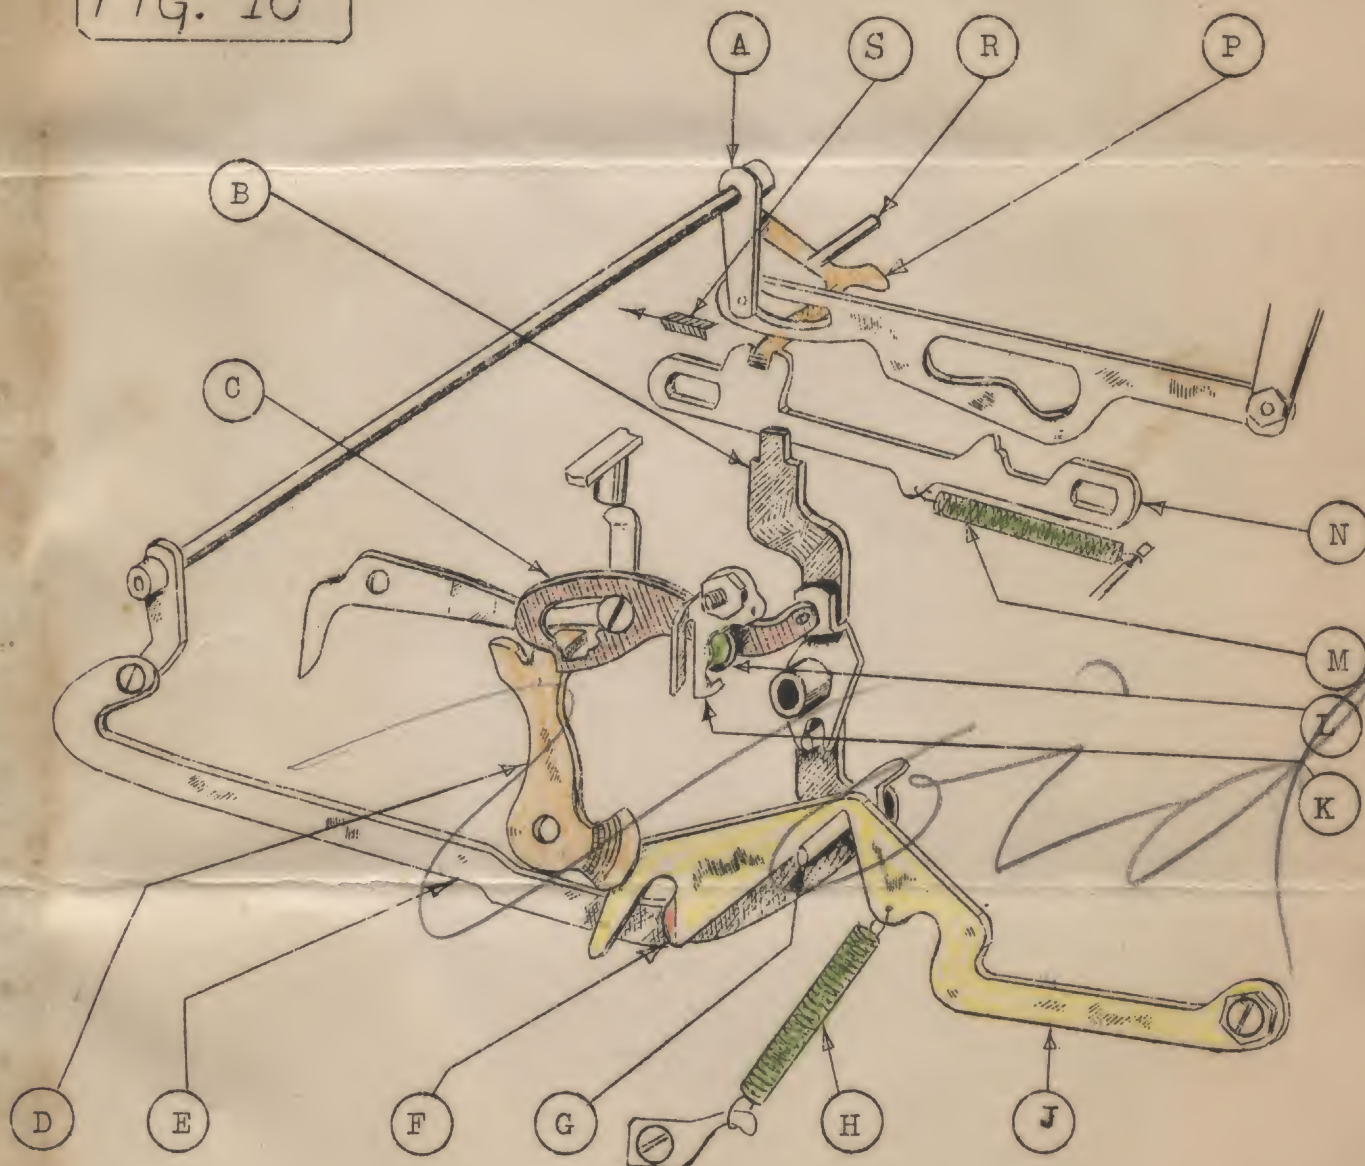
FIG. 10

Additional stock, as shown in red, has been added to the division lever click (J) because when the multiplication lever was restored to neutral at the completion of a problem, the pin (R) on the main shaft gear would strike the lever (P) which, instead of pulling latch (N) in the direction of arrow (S), would apply pressure on arm (A) causing link (E) to move stud (G). The original click (J), due to the degree of angle at (F), could not prevent this.

To remedy a condition wherein the division lever (B) fails to restore or restores sluggishly, a button of .040 thickness (L) has been added to the guide blank (K). This prevents the blank (C) from camming out of engagement with the restoring arm (D) as shown.

NOTE: - Do not change the original tension of springs (H) and (M) as additional tension increases the load of restoring the division lever.
